CERTIFICATE OF APPROPRIATENESS**Application Date:** August 3, 2014**Applicant:** Michael & Laura Czapski, owners**Property:** 528 Highland Street, Lot 8 & Tract 7, Block 20, Woodland Heights Subdivision. The property includes a historic one-story residence situated on a 7,500 square foot (75' x 100') corner lot.**Significance:** Contributing Queen Anne residence with Colonial influence, constructed circa 1915, located in the Woodland Heights Historic District.**Proposal:** Alteration – Request for HAHC approval of completed and partially completed alterations that have exceeded the scope of work approved in two previous COAs.

The applicant received a COA in February 2014 for a two-story rear addition to a one-story contributing house. In March, the applicant was red-tagged for removing all of the shiplap from the original house without approval. He was granted a COA in April 2014 for this unapproved work.

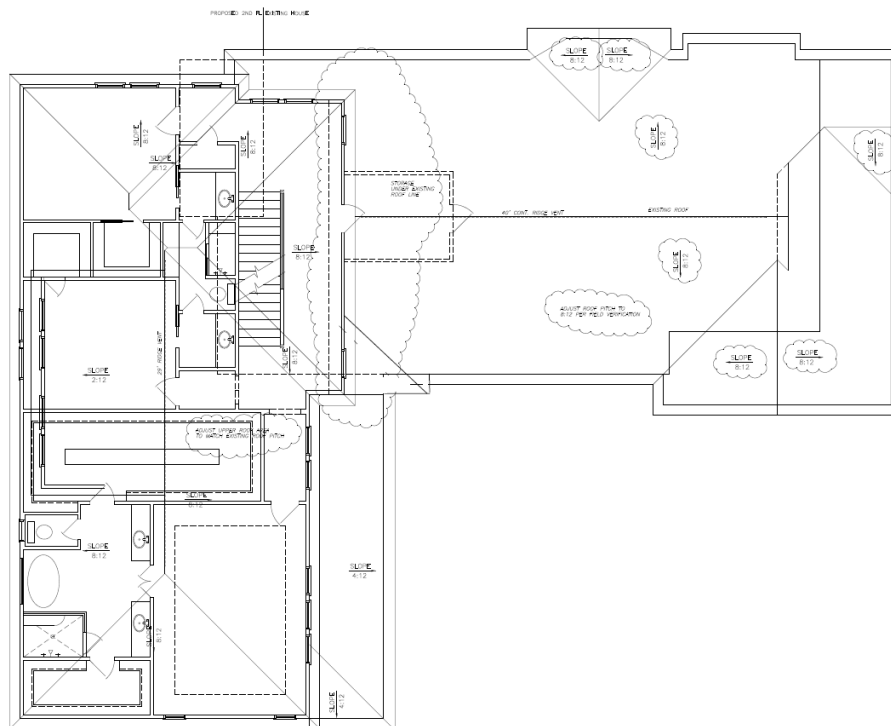
PROPOSED AUG.-SEPT. 2014 (AS BUILT)

- Roof pitch of the addition was increased from 6:12 to 8:12.
- Ridge height as constructed is 2' taller than approved (32'-6" rather than 30'-5").
- Second story addition encroaches an additional 18" into the original structure.
- Construction of a bump-out approximately 3' wide by 11' long on east elevation of original structure that resulted in the removal of an additional 11' of the original exterior wall and required a change to the approved roof shape.
- Removal of all original wood siding behind the bay window on the west elevation and replacement with cementitious siding.
- Removal of the front porch decking, railing, and ceiling beadboard.
- Installation of a window on the rear portion of the east elevation of the addition.

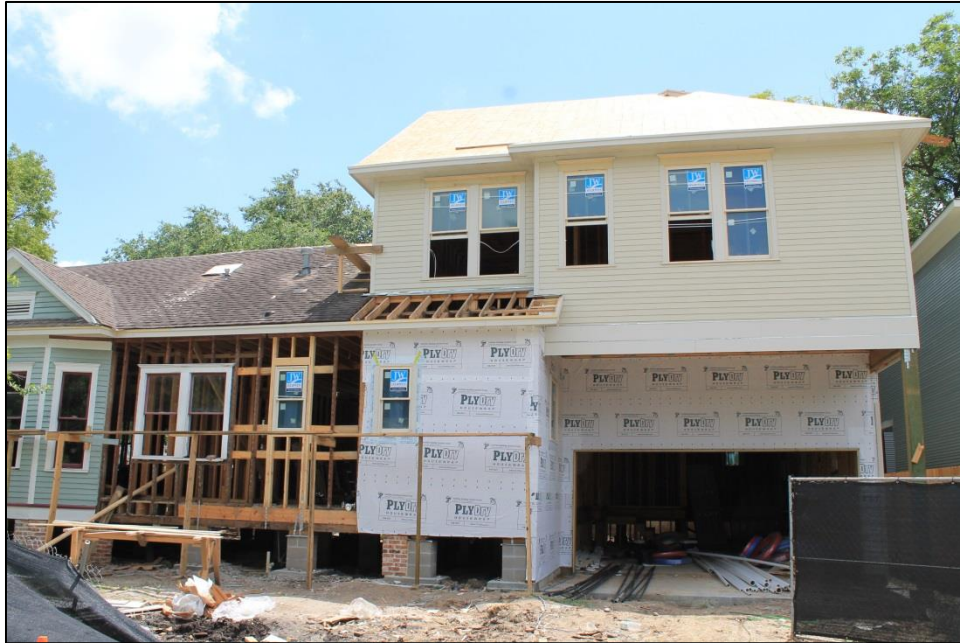
Staff Photo: 06/27/2014

Applicant continued to work after notified to stop all unpermitted work
